Reduction of unforged bar bulb in engine valve manufacturing

Abstract—Valves play an important role while converting chemical energy into mechanical energy during the cycle in IC engine. The valves made of several processes like preparing cut bar, upsetting and forging in the premachining. At the premachining stage of valve manufacturing, there are manual and robot-assisted forging shop used to produce the head of the valve from preformed bar or bulb produced bar. In this project, the ways to reduce the unforged bar bulb at the robot-assisted forge shop are found. The root cause analysis (RCA) method is used to find the problems which cause unforged bar bulb. From the analysis, It has been found that the major cause of the occurrence of the unforged bar bulb is the stem bend. Because of there is no guidance for the bar, the stem bends while upsetting and it leads other causes like loss of copper jaws life, Robot collision, die damage, etc., In order to overcome this main and other causes, the design of the upsetter stopper bush is redesigned. By doing this, the quality and quantity of valves in production are increased, the occurrence of the unforged bar bulb is reduced and stem r

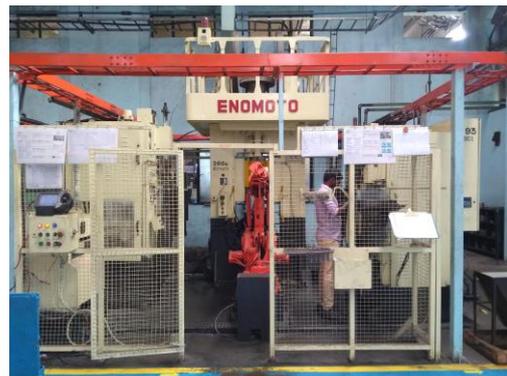
Figure 2. Forge shop

In the forge shop where the head of the valve is produced. First, the raw material is prepared as a cut bar for the premachining. Then it brings to the forge shop of premachining. The cut bar is loaded by the operator. Then loading unit loads the cut bar to an upsetting machine. By upsetting the cut bar, the onion-shaped bulb is produced. The copper jaws and Mallory anvil act as electrodes and by placing the cut bar, the circuit gets closed. The robot picks preformed

bar from upsetter and places it in the die. At the die, the temperature of the bulb is monitored to ensure that it is within range of 850°C to 1100°C. If it is not, it cannot be forged. The pyrometer pointed towards the direction of the bulb. If bulb temperature is within the range, the press produces head by applying force. Then the unloading unit is used to unload valve to bin.

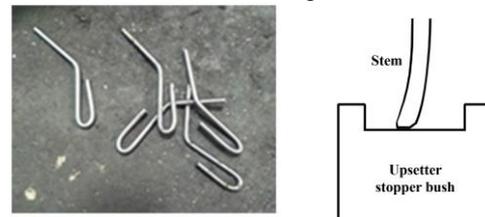
Figure 5. Stem bend

There is no guidance for the bar. So stem slides over the surface of the stopper bush during the process. Owing to this, Stem bends while upsetting process. It causes high stem run out (Stem run out should be up to 0.3mm). So the bars that have high stem run out will be a burden in straightening process. When these bars placed in the die, it cannot be placed properly and it cannot get into die. So, the unloader unloads this bar which is not forged.

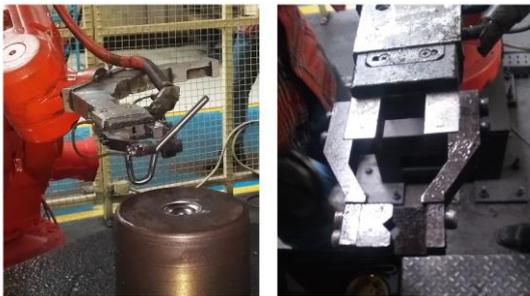
Figure 8. Gripper misalignment

When the robot gripper picks the bent job from upsetter machine, alignment of the gripper gets changed. If it happened, the gripper cannot pick and place the job properly. It also causes unforged bar bulb.

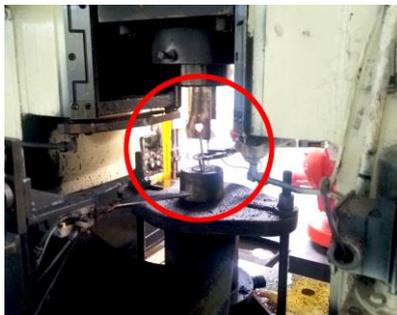
Figure 9. Robot collision

Either job get stuck at die or bar bends while upsetting causes the robot collision. The collision of the robot is as shown in Figure 9. This also causes robot position change. If the position of robot changes, it cannot perform the task properly. So engineer needs to teach the robot and it also consumes more time.
